**DEPARTMENT OF TRANSPORTATION****DIVISION OF ENGINEERING SERVICES**

Contract #: 04-0120F4Cty: SF/ALA Rte: 80 PM: 13.2/13.9File #: 69.28**WELDING INSPECTION REPORT****Resident Engineer:** Pursell, Gary**Address:** 333 Burma Road**City:** Oakland, CA 94607**Report No:** WIR-007282**Date Inspected:** 31-May-2009**Project Name:** SAS Superstructure**OSM Arrival Time:** 700**Prime Contractor:** American Bridge/Fluor Enterprises, a JV**OSM Departure Time:** 1700**Contractor:** Zhenhua Port Machinery Company, Ltd (ZPMC), Changxing Island **Location:** Shanghai, China**CWI Name:** Wu Zhi Cheng**CWI Present:** Yes No**Inspected CWI report:** Yes No N/A**Rod Oven in Use:** Yes No N/A**Electrode to specification:** Yes No N/A**Weld Procedures Followed:** Yes No N/A**Qualified Welders:** Yes No N/A**Verified Joint Fit-up:** Yes No N/A**Approved Drawings:** Yes No N/A**Approved WPS:** Yes No N/A**Delayed / Cancelled:** Yes No N/A**Bridge No:** 34-0006**Component:** OBG crossbeams**Summary of Items Observed:**

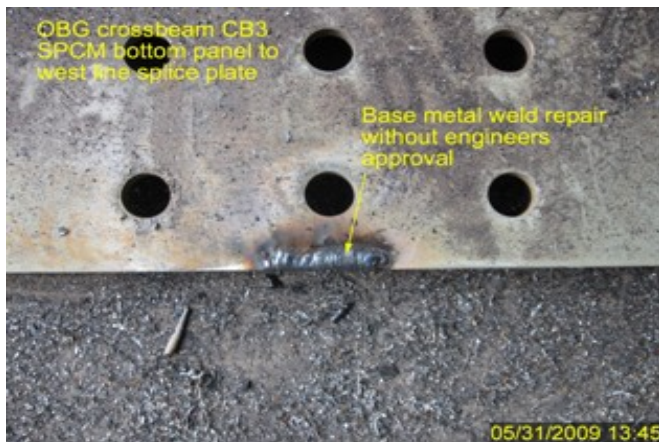
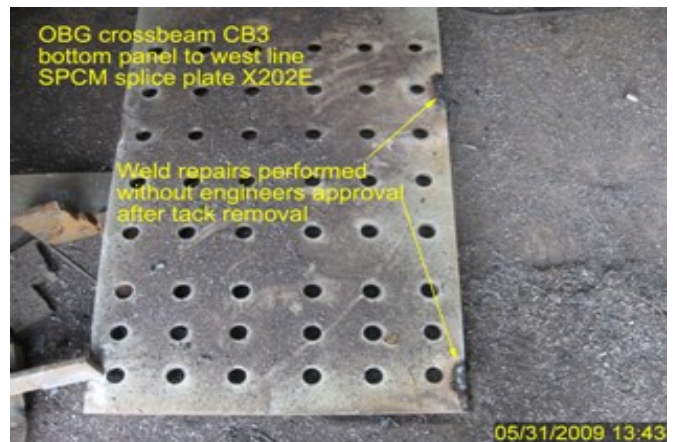
This QA observed that ZPMC personnel have commenced base metal weld repairs on crossbeam CB3 splice plate X202E without the Engineers approval. The areas being repaired were previously damaged while removing temporary tack welds joining this plate to the bottom panels of the crossbeam (CB3) and OBG segment 4BW. The splice plate is designated as SPCM. See attached photos. AWS D1.5 2002 section 3.3.7.3 states "Tack welds not incorporated into the final weld shall be removed in such a manner that the base metal is not nicked or undercut. Repair of base metal accidentally removed shall be approved by the Engineer prior to making the repair. This QA notified ZPMC QA identified as Mr. Wang Lu and ABF QA inspector identified as Mr. Li Jing Bo of this non conformance and informed both that an incident report would be generated for this issue.
